365 Hale Road,  
Widnes,  
WA8 8TR.

On behalf of Charles Brierley-Jones.

## Ecological Appraisal

Report number:	WID/001	Author:	C. Leigh
Date:	25 <sup>th</sup> April 2022	Approved:	C. Evans

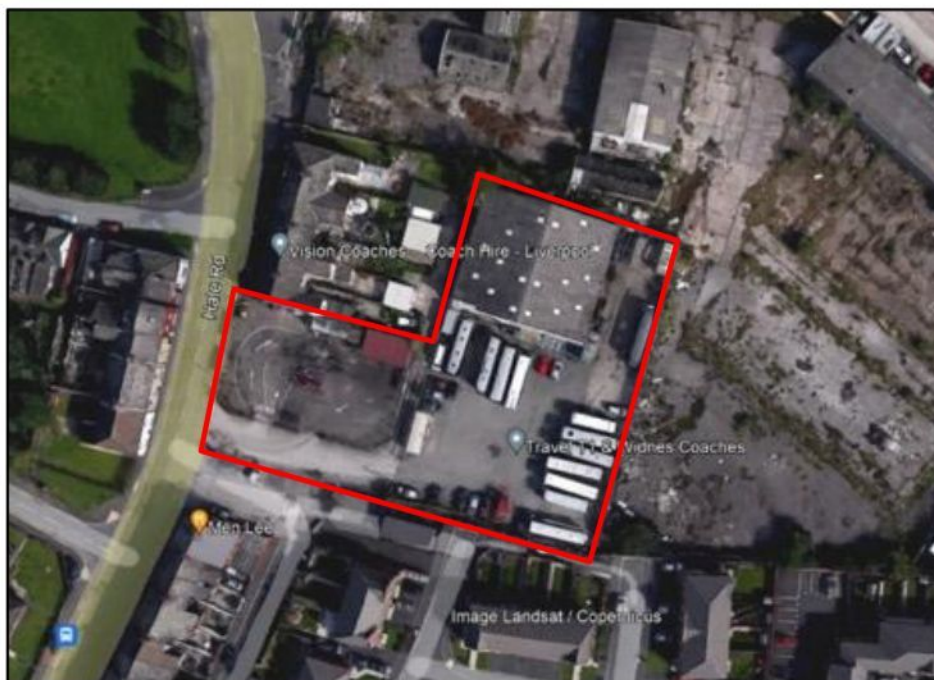
Figure 2.1; Site location and extent

- 2.1 Leigh Ecology Ltd was commissioned by Charles Brierley-Jones to undertake an Ecological Appraisal of a site featuring a coach warehouse and car wash complex at 365 Hale Road (approx. National Grid Reference (NGR) SJ489846); refer to redline boundary shown on Figure 2.1 below.

- 5.1 The proposed development (within the red line site boundary as shown in Figure 2.1) will consist of the removal of the current buildings on site, followed by the subsequent development of a large care home facility.
- 5.2 Construction and post construction impacts are therefore possible upon both the habitats and species within and immediately adjacent to the site. Ecological constraints and recommendations with regard to any development of the site are discussed below.

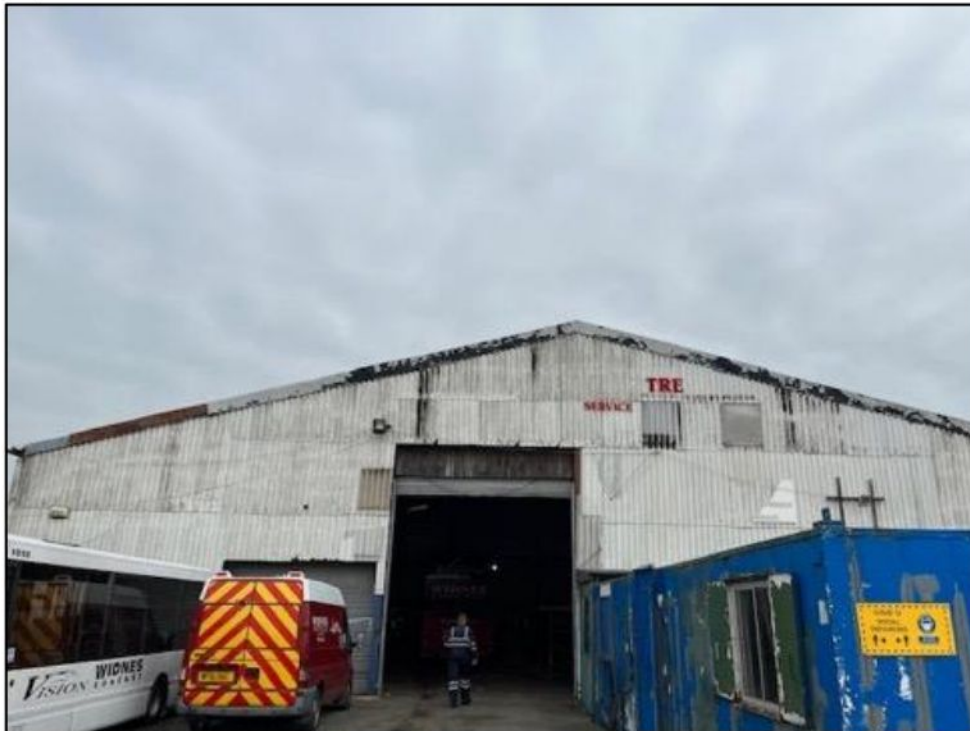
**Photograph 1:** A front view of the large corrugated storage/workshop building.

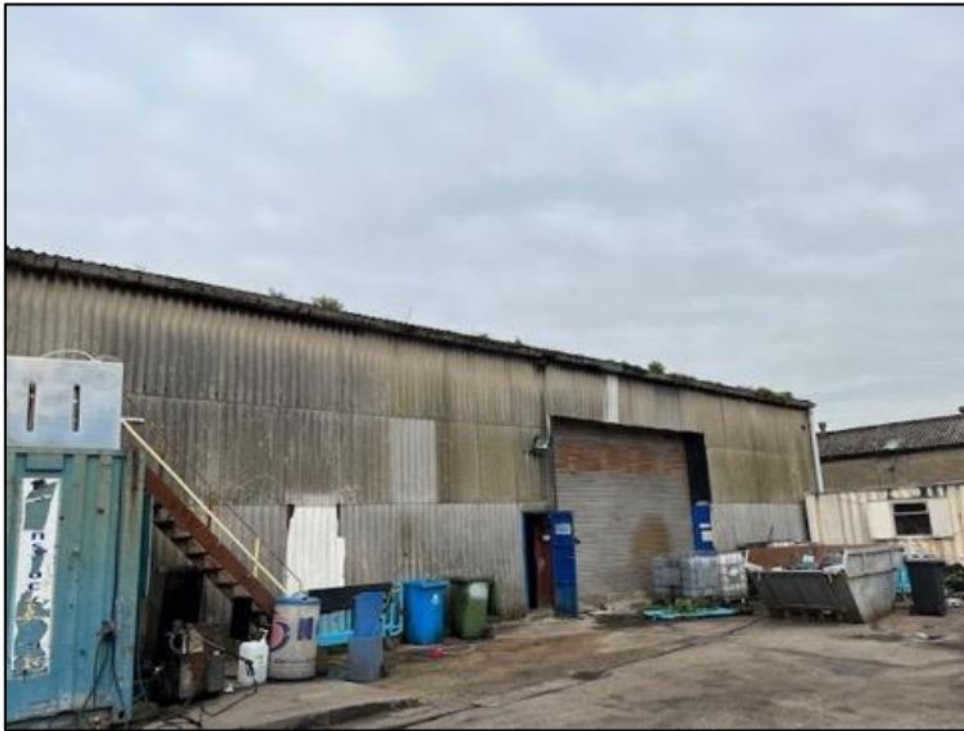
**Photograph 2:** A view of the building from the western face. The dominant land on site is hard standing concrete, with small unit features such as corrugated steel building units.

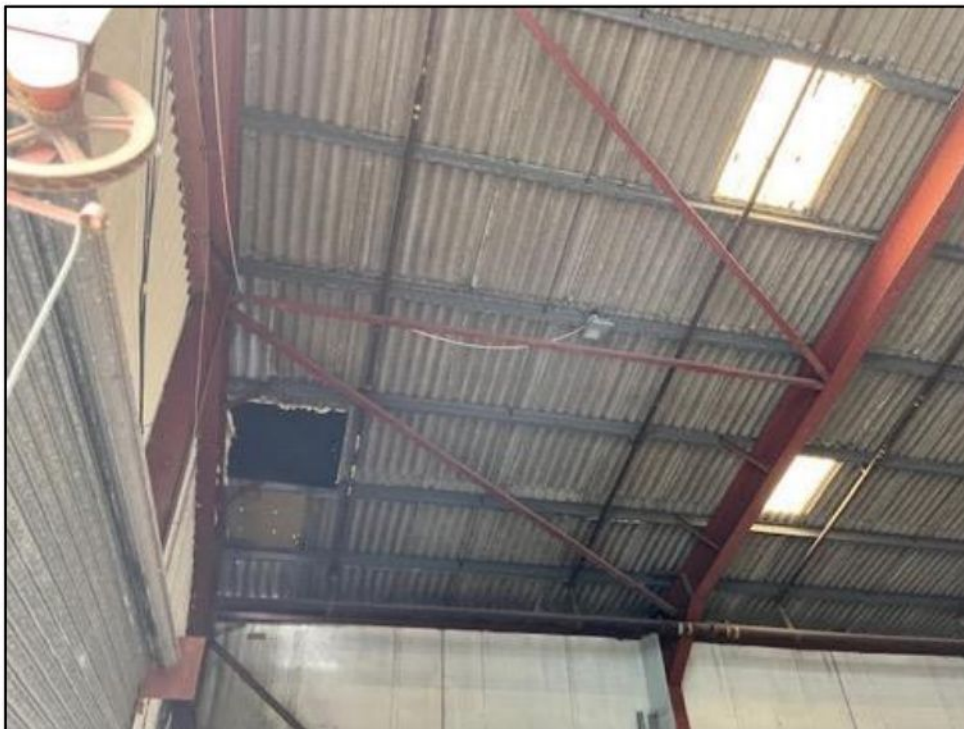
**Photograph 3:** An internal view of the large workshop/storage building. A worker on site stated that nesting wood pigeons frequent the site, but no active nests were noted.

- 4.13 The site offers some bird nesting habitat within the large, corrugated building, and previous wood pigeon usage has been noted within this subject building. Clear entry points are created between the roof and the exterior walls and should be considered during the removal process.

5.18 In conclusion, it is thought that proposal works can go ahead without constraints. Since nesting wood pigeons have been previously noted on site, workers should remain vigilant for any signs of new usage.

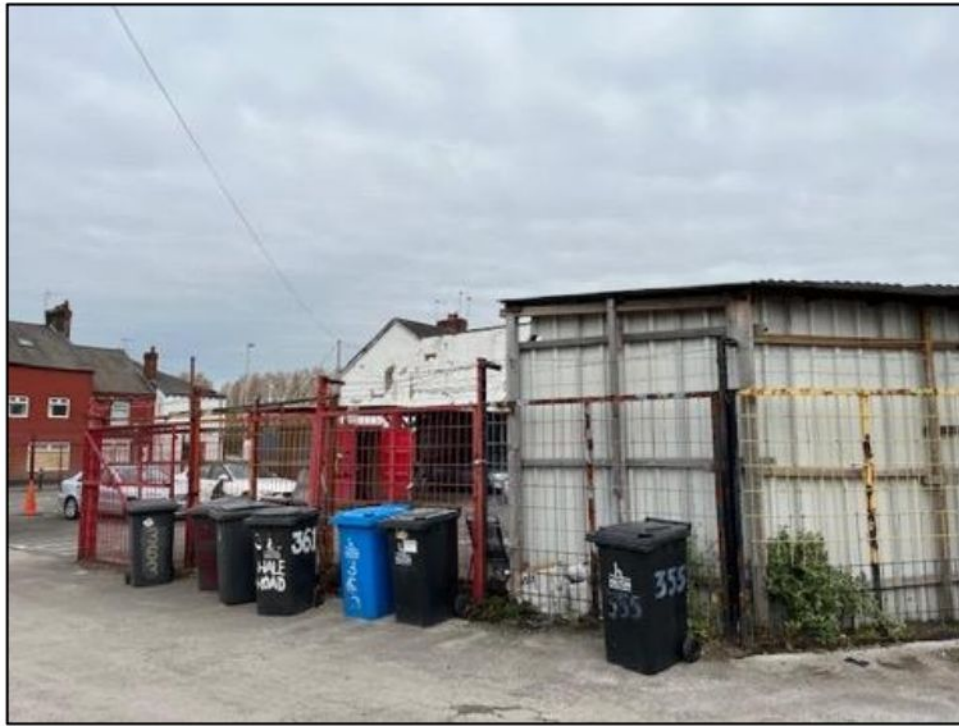
**Photograph 4:** A view towards the car wash complex on site. Corrugated tin buildings feature as shelter for the work; none of these buildings offer any ecological value.

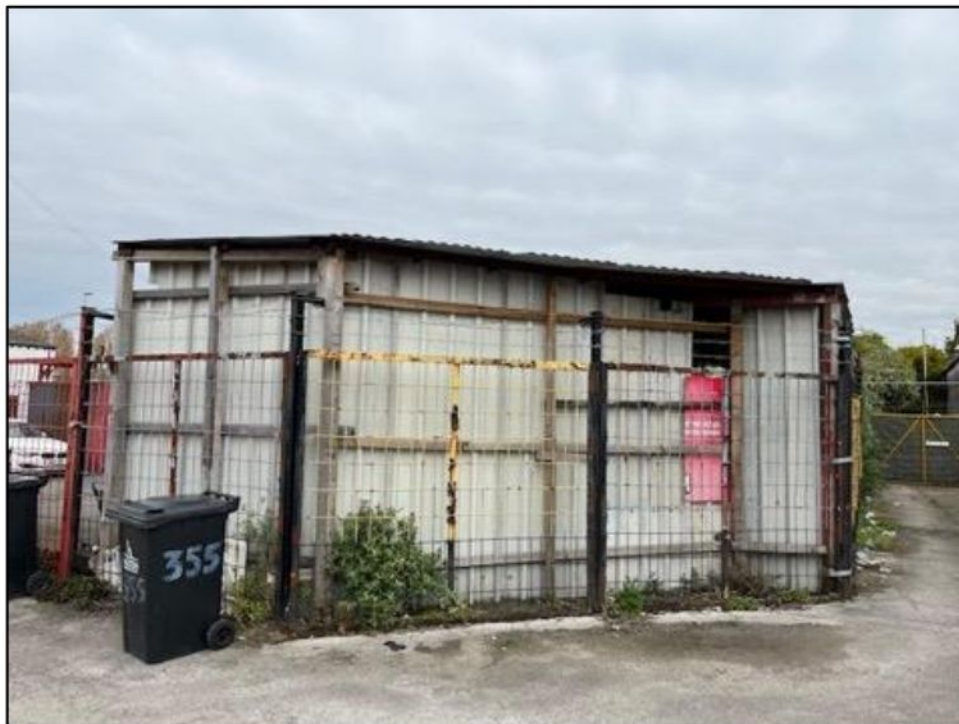
**Photograph 5:** A metal fence separates the car wash from the adjacent building on site. Small shrubs are found in these areas but are of no concern.

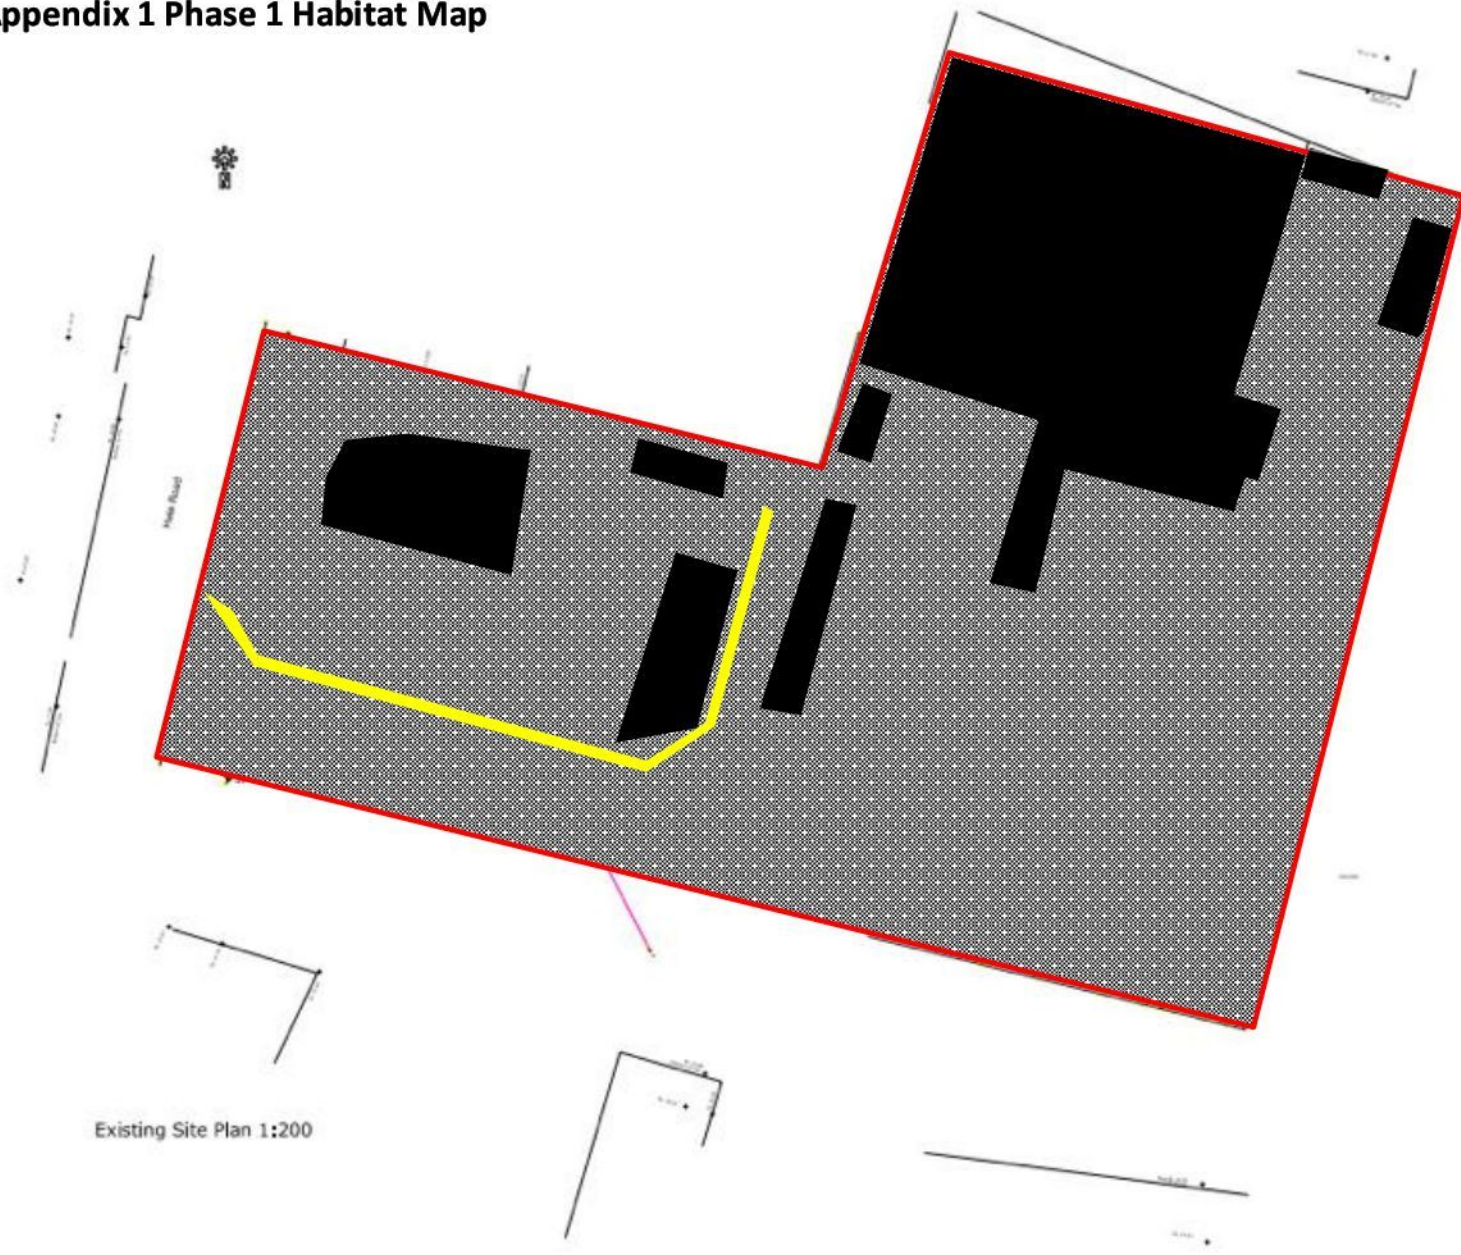
Appendix 1 Phase 1 Habitat Map

- 4.1 The locations of the habitats within the survey area are shown in **Appendix 1**, which should be read together with the accompanying Target Notes (TNs); refer to **Appendix 2** and Photographs within the text. Habitat descriptions are provided below; plant species are referred to using their English names.

- 4.2 A map showing the habitat areas is presented in **Appendix 1**.
- 4.3 The following paragraphs describe the habitats within the proposed site, providing a basic description of the most dominant species occurring.
